## **Results of Some Hardness Testing on a Hammered Scythe Edge**

Prepared for:  
Mr. Peter Vido

Prepared by:  
Dr. J.C. Thornley  
Physical Metallurgy Department

Report No.: PM/05/Scythe  
Date: 25<sup>th</sup> January 2005

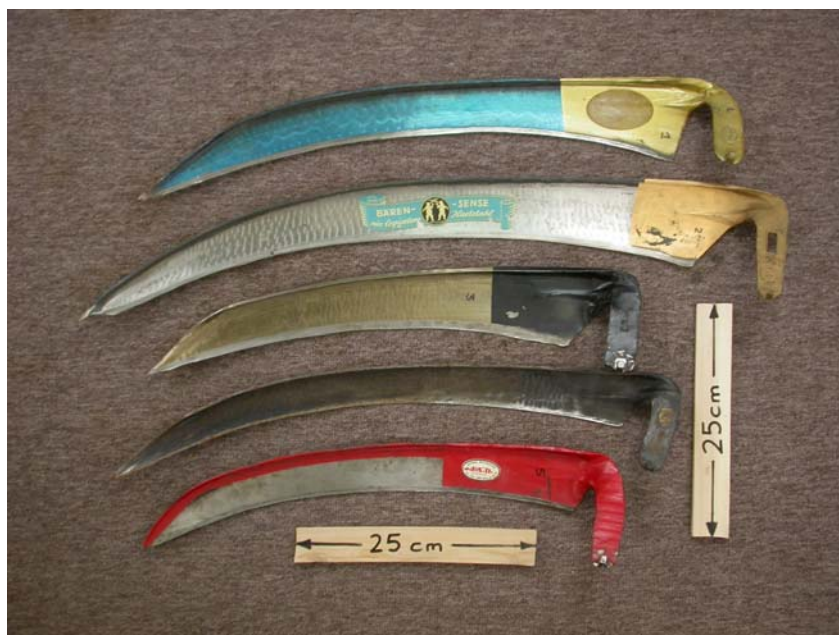
**Figure 1.** The blades are numbered 1 to 5 from top to bottom in this photograph. The uppermost one is of contemporary Slovenian production. Blade #2 is a pre-war Austrian blade and #3 is also Austrian but of 1950's vintage. The all dark blade, #4, is Turkish and perhaps 30 or 40 years old while blade #5 is of current Chinese production.

The blades for testing were provided by Mr. Peter Vido and are shown in Figure 1 below.

minor or can make the blade unusable. Only one blade was tested this way in this instance. Three sections were cut out of the #1 blade. As it says in the caption to Figure 1 this blade was a current Slovenian blade. It had been factory hammered three times with additional hand hammering over about three inches (about 7 or 8 cm) close to the heel. The positions at which sections were taken from the blade are shown in Figure 2.

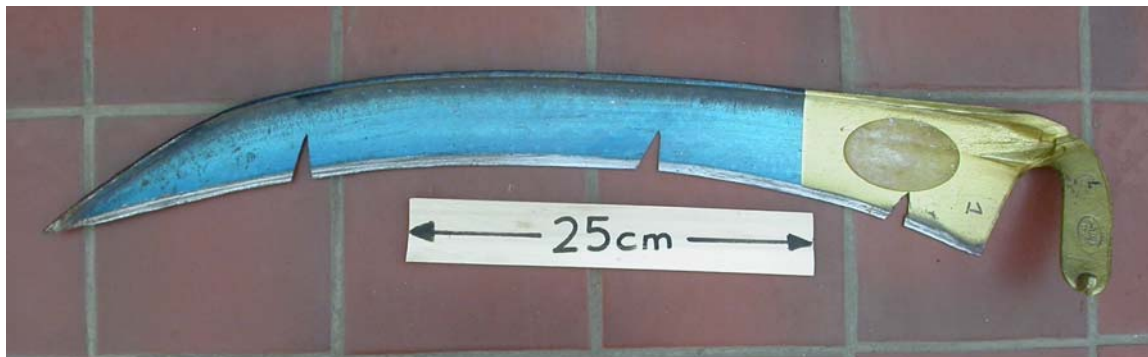
**Figure 2.** The three notches in the blade were made by cutting small samples out of the blade for hardness testing. Each sample was set in plastic to show the cross section of the cutting edge and was then polished, finishing with 1  $\mu\text{m}$  diamond paste. The hardness impressions were then made on these prepared sections. The sections were numbered 1, 2 and 3 going away from the heel of the blade that is, right to the left in the photograph.

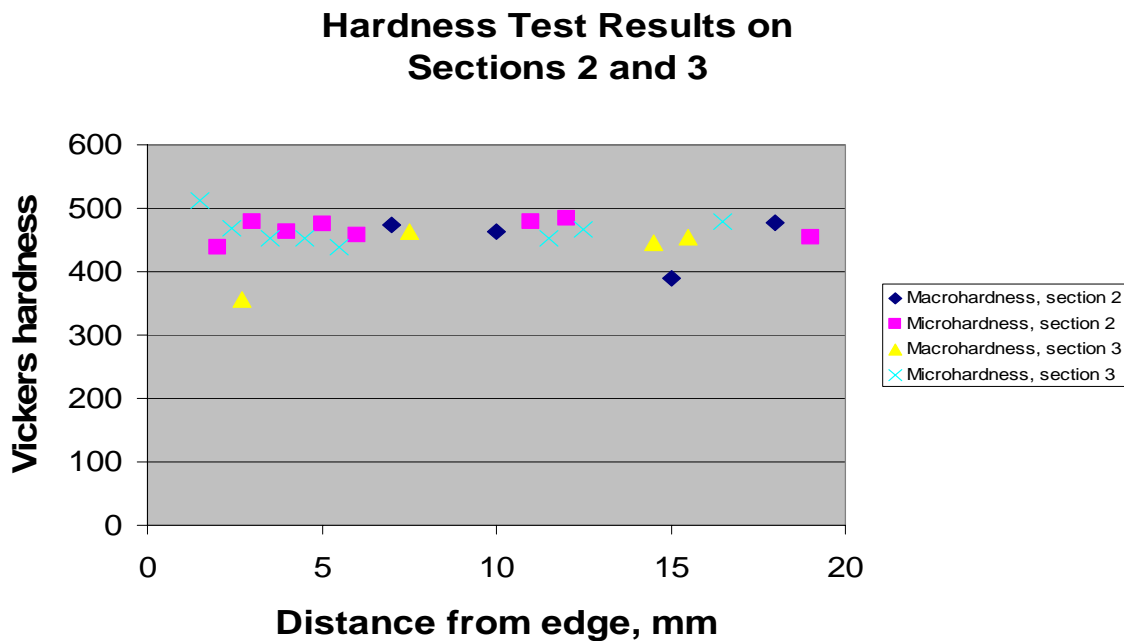
**Figures 4.** Test results from sample #1. The graph gives the results from the two samples taken away from the heel. (See figure 2 for the position of these samples.) There is little change in hardness at these positions as the blade edge is approached.

The average hardness in the “core” of the blade, at all three section positions, was about 430 Vickers diamond pyramid number (VHN). This corresponds to a hardness of about 44 Rockwell C. (A 10 kg load was first used for this core hardness testing.) The core hardness was also measured using a microhardness testing machine. The result from this testing was about 460 VHN, corresponding to about 46 Rockwell C, in reasonable agreement with the Vickers macrohardness results. Microhardness tests were then made closer to the cutting edge. These tests showed that the hardness increased only very slightly in the sections taken from the positions which had simply been factory hammered but there was a modest hardness increase, to about 560 VHN

These results are shown graphically below in Figures 3 and 4 and the hardness positions are shown in a separate sketch.
