## Results of Some Hardness Testing on a Hammered Scythe Edge

Prepared for:  
Mr. Peter Vido

Prepared by:  
Dr. J.C. Thornley  
Physical Metallurgy Department

Report No.: PM/05/Scythe  
Date: 25<sup>th</sup> January 2005

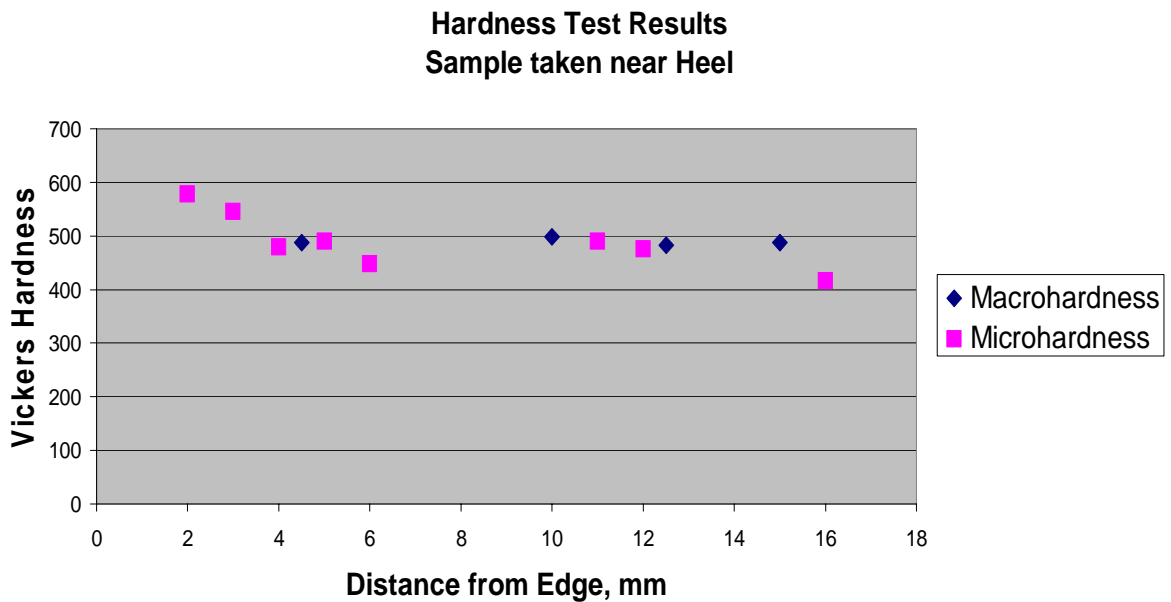
**Figure 3.** Test results from sample #1. The graph shows the results from near the heel of the scythe (section 1). In it, note the modest rise in hardness at positions within 3 mm of the blade edge. (The blade edge is the "0" position on the graph.)

The average hardness in the “core” of the blade, at all three section positions, was about 430 Vickers diamond pyramid number (VHN). This corresponds to a hardness of about 44 Rockwell C. (A 10 kg load was first used for this core hardness testing.) The core hardness was also measured using a microhardness testing machine. The result from this testing was about 460 VHN, corresponding to about 46 Rockwell C, in reasonable agreement with the Vickers macrohardness results. Microhardness tests were then made closer to the cutting edge. These tests showed that the hardness increased only very slightly in the sections taken from the positions which had simply been factory hammered but there was a modest hardness increase, to about 560 VHN

(53 Rockwell C), in the region that had been hand hammered. (The hardness close to the cutting edge was only measured by a microhardness method.)

These results are shown graphically below in Figures 3 and 4 and the hardness positions are shown in a separate sketch.
